February 2001

# Mill Creek

Flood Control Project  
Radial Gate Investigations

13. ABSTRACT (Maximum 200 words) This report is an evaluation of the overall condition of the spillway tainter gates at Mill Creek Flood Control Project, Walla Walla, Washington

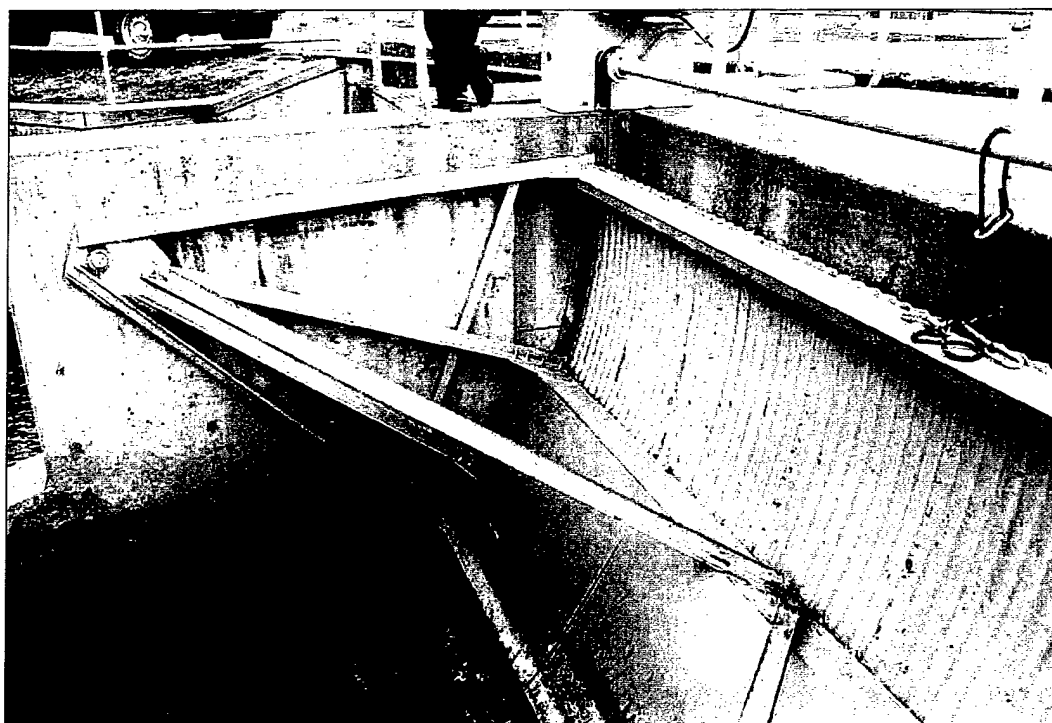
*Photo 1 - 6 ft. x 14 ft. Armco Gate*

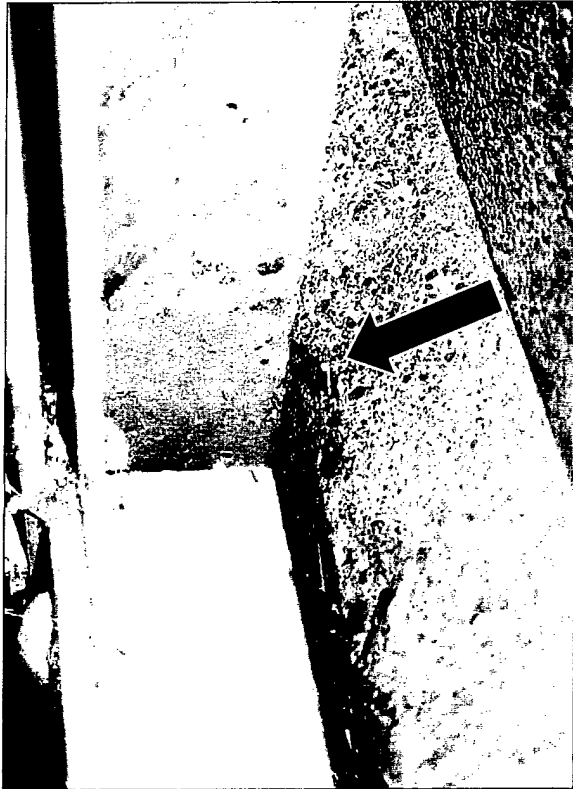
- The entire gate is shifted significantly to the right (looking upstream). The left side frame is in contact with the pier wall near the upstream end of the bottom radial strut. Scraping and gouging of the concrete pier is evident at the bottom of the pier. See photo 23.

***Photo 23 - Left frame in contact with pier wall.  
Note: small steel ruler in gap between radial strut brace and concrete pier wall.***

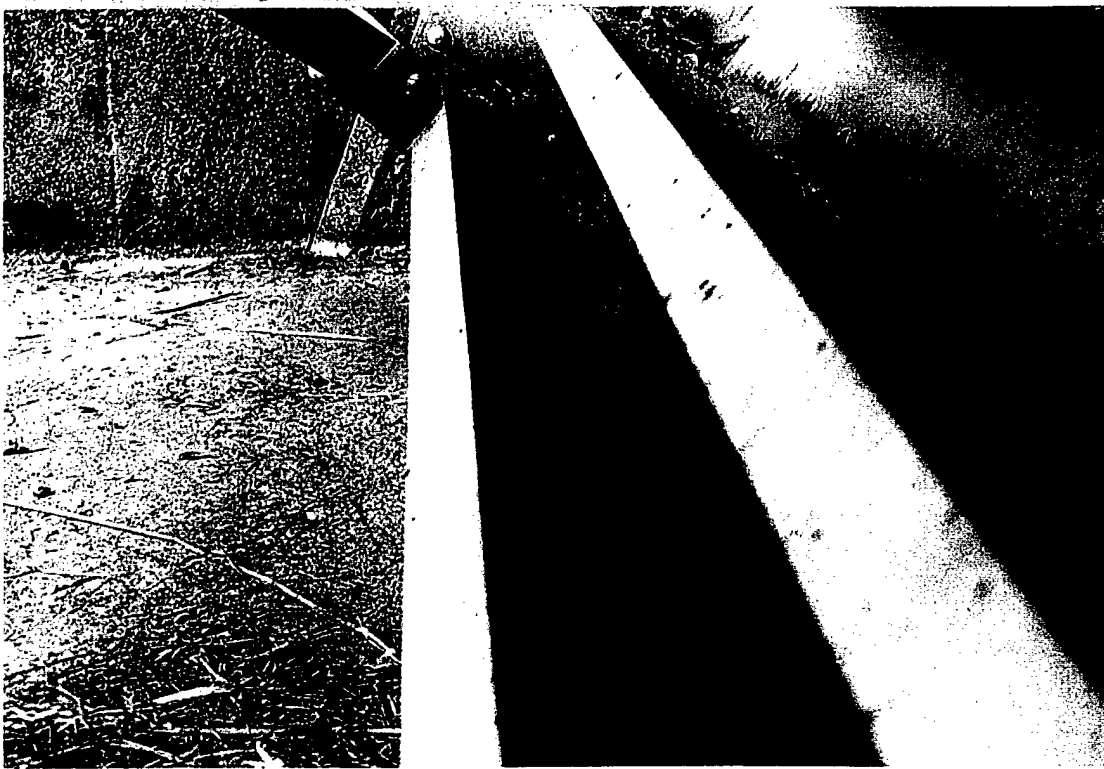
Gate 1 - 8'x18'  
Inside of bottom horizontal girder  
looking toward right frame. Debris  
and evidence of standing water on  
girder web and skin plate.

- Drainage holes should be provided for the horizontal girders which are rotated to cause ponding against the skin plate. The drain holes should be 1-inch in diameter and spaced at approximately 24-inches along the girders. The edge of hole should be located approximately 1/2-inch from the girder flange. The holes should be drilled, not flame cut (the use of a mag-drill is recommended). If flame cut holes are the only available option, the edges of the holes should be reamed smooth.

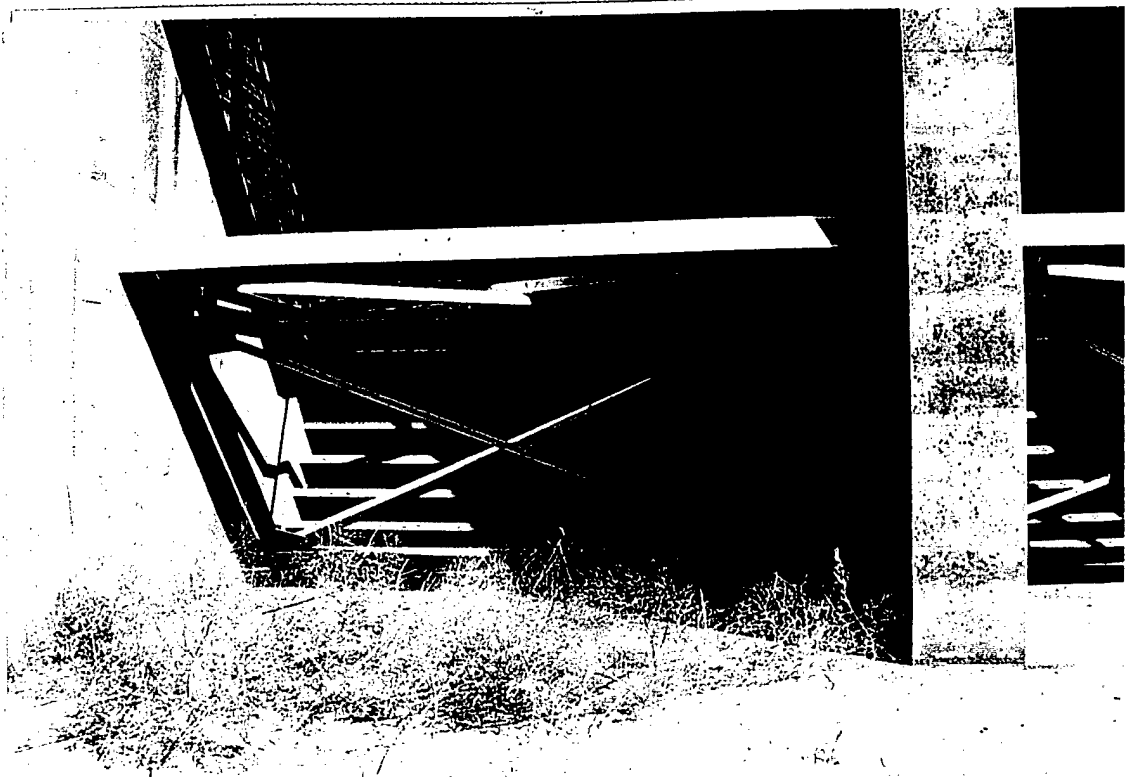
Gate overview.

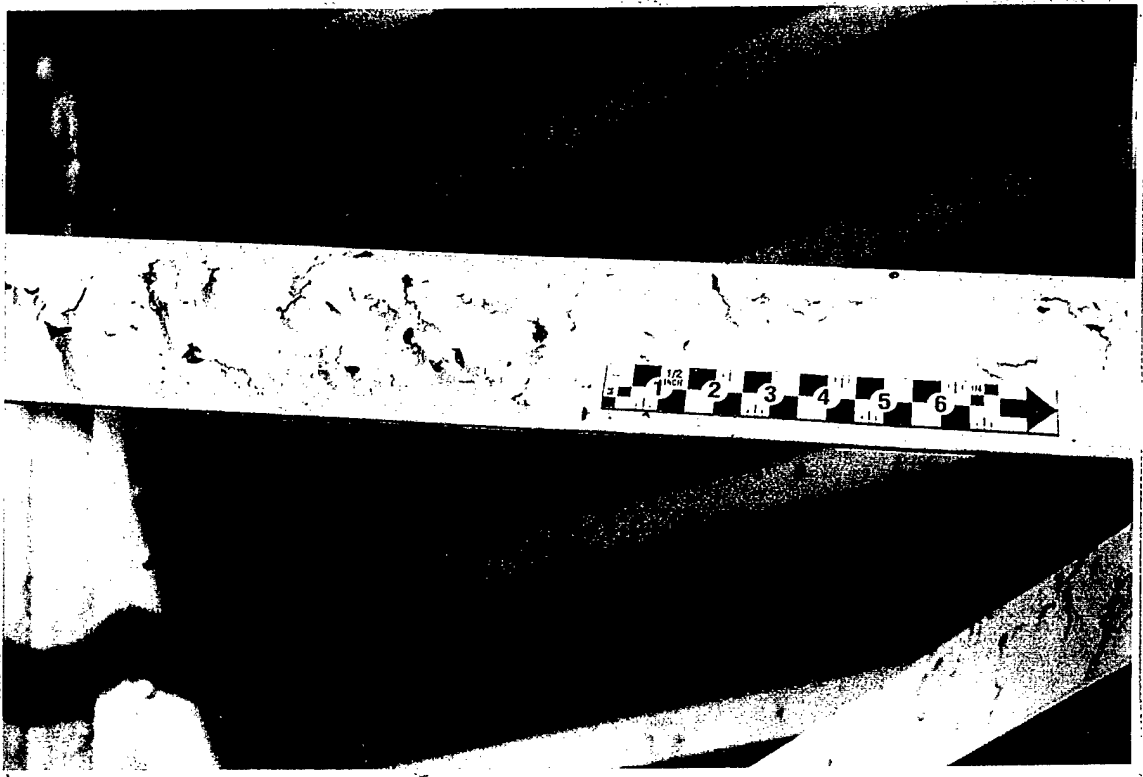
2-1

Gate 2 - 8'x18'  
Gate overview.

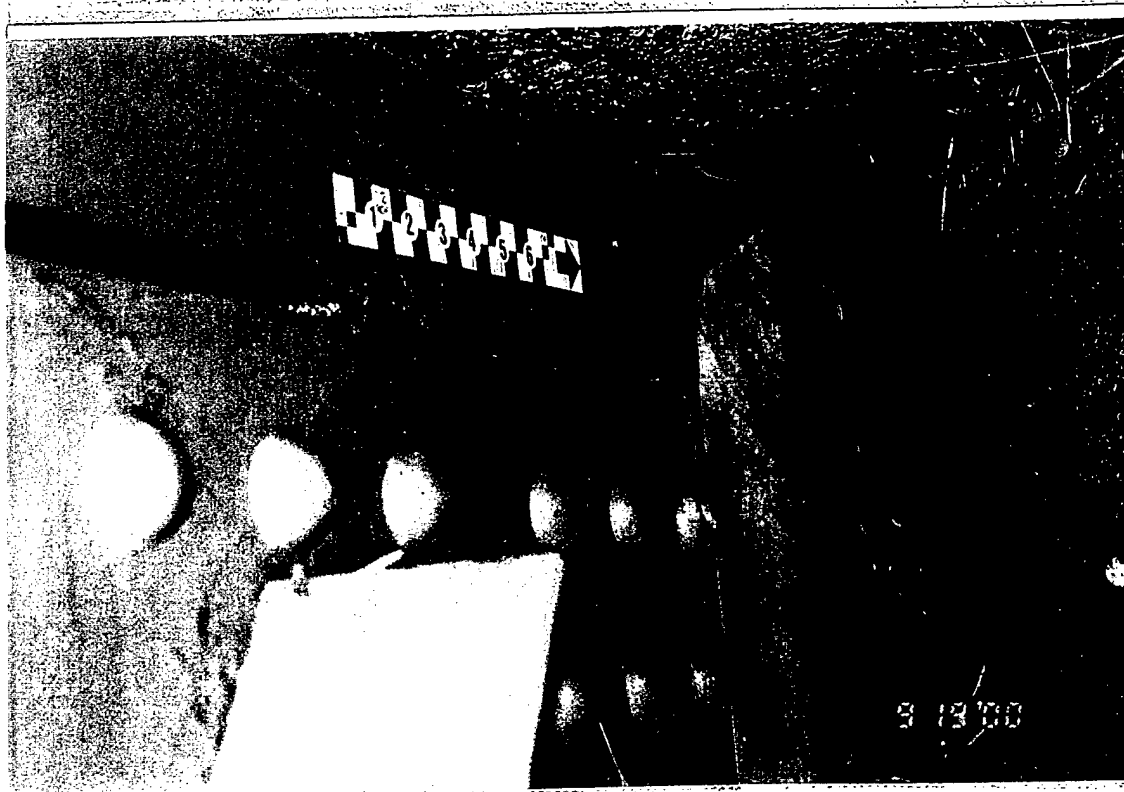
2-3

**Gate 2 - 8'x18'**  
Bottom left side of gate at timber  
bumper. Splitting at end of bumper.

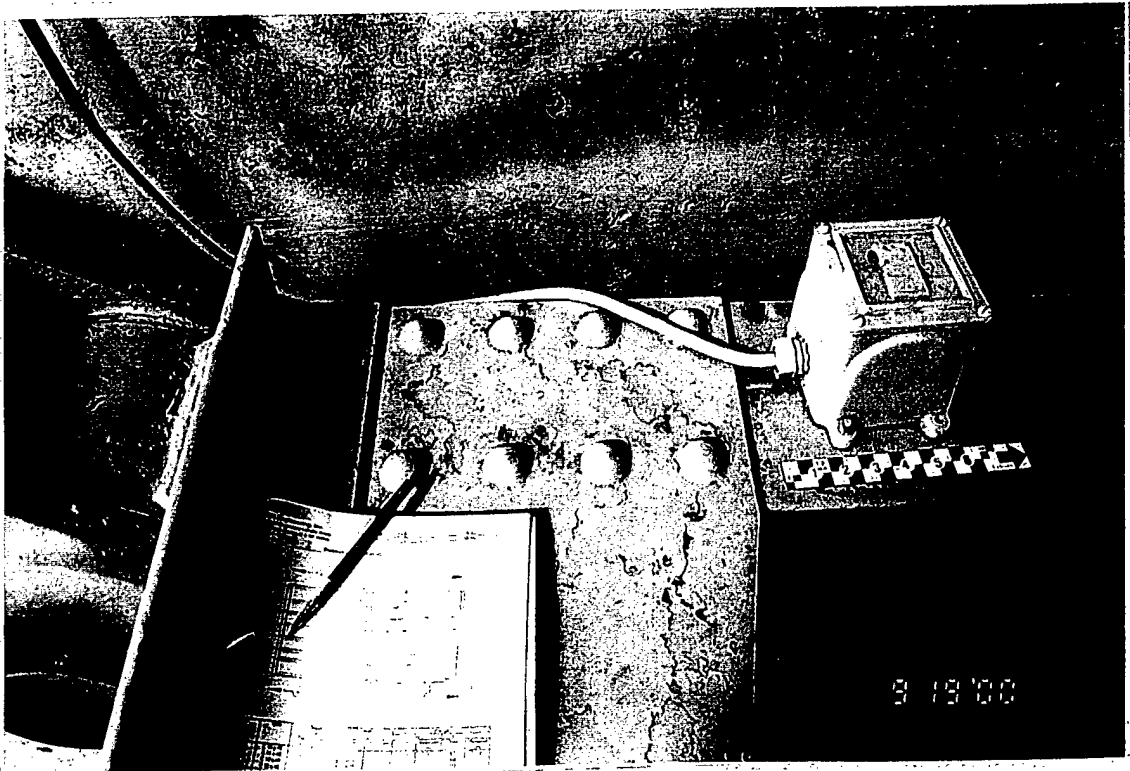
2-14

Gate 2 - 8'x18'  
Top of right trunnion and trunnion  
beam. Flaking paint and light  
isolated corrosion. Note: lubrication  
fitting on trunnion pin.

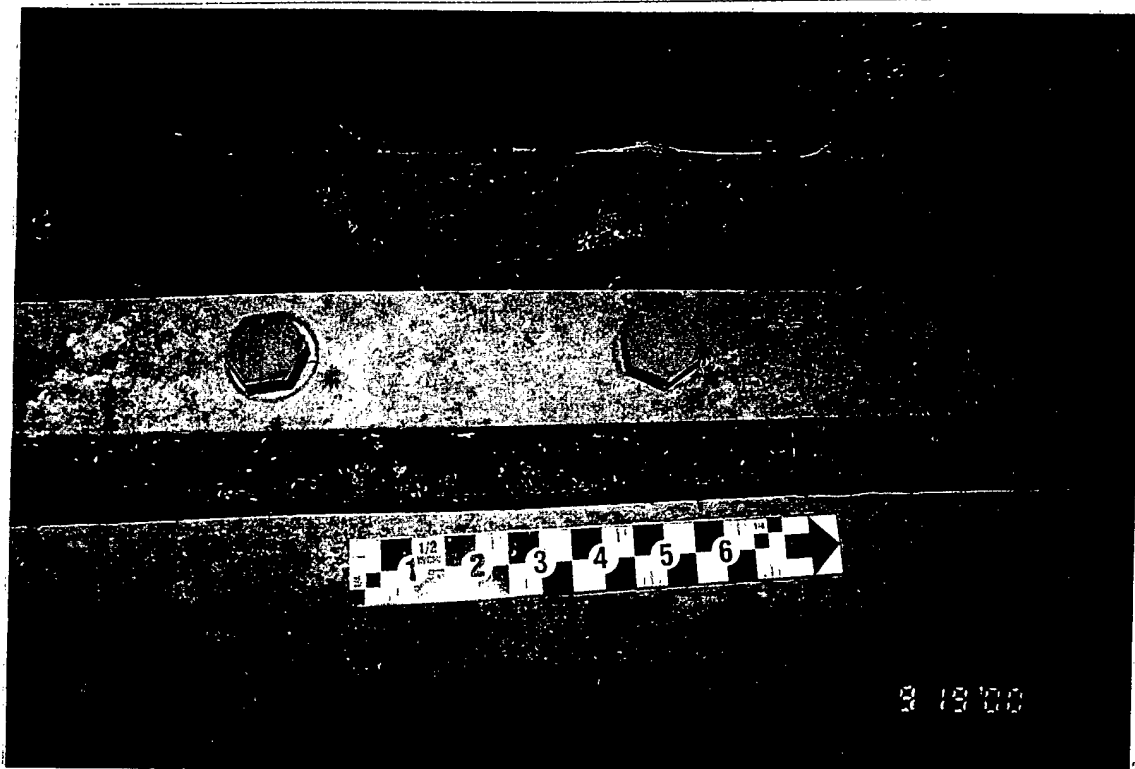
2-17

Gate 2 - 8'x18'  
Upstream side of skin plate, typical.

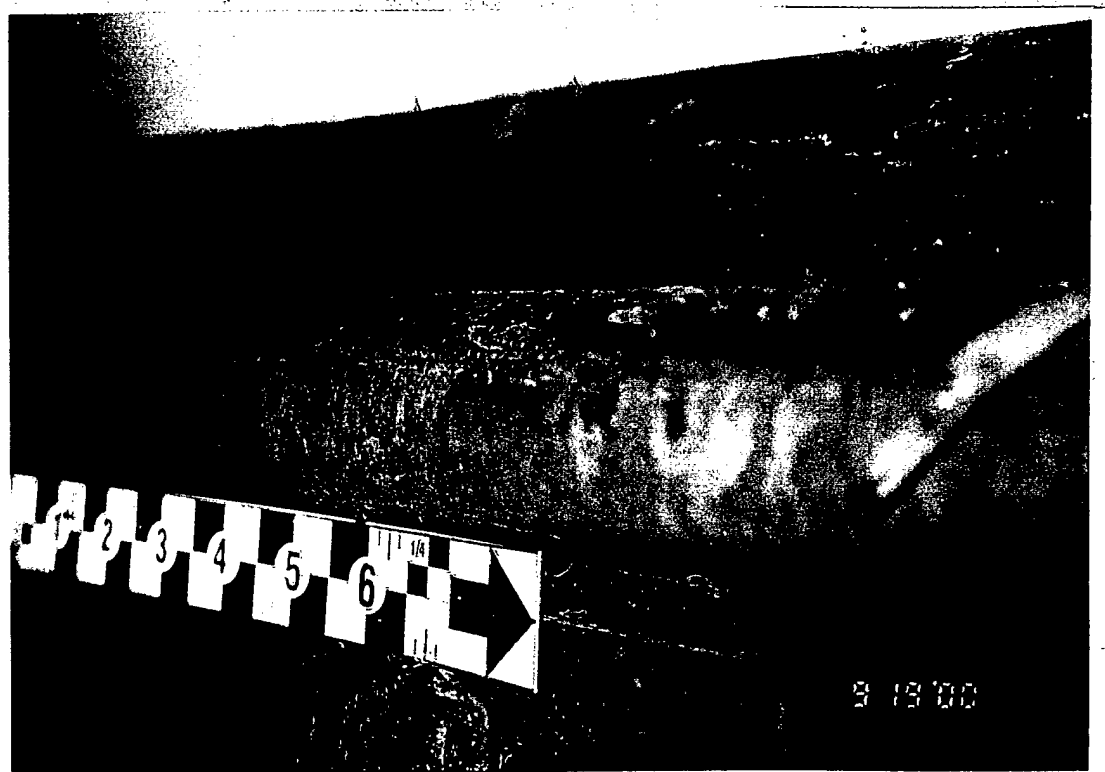
2-19

Gate 2 - 8'x18'  
Close-up of skin plate, typical.

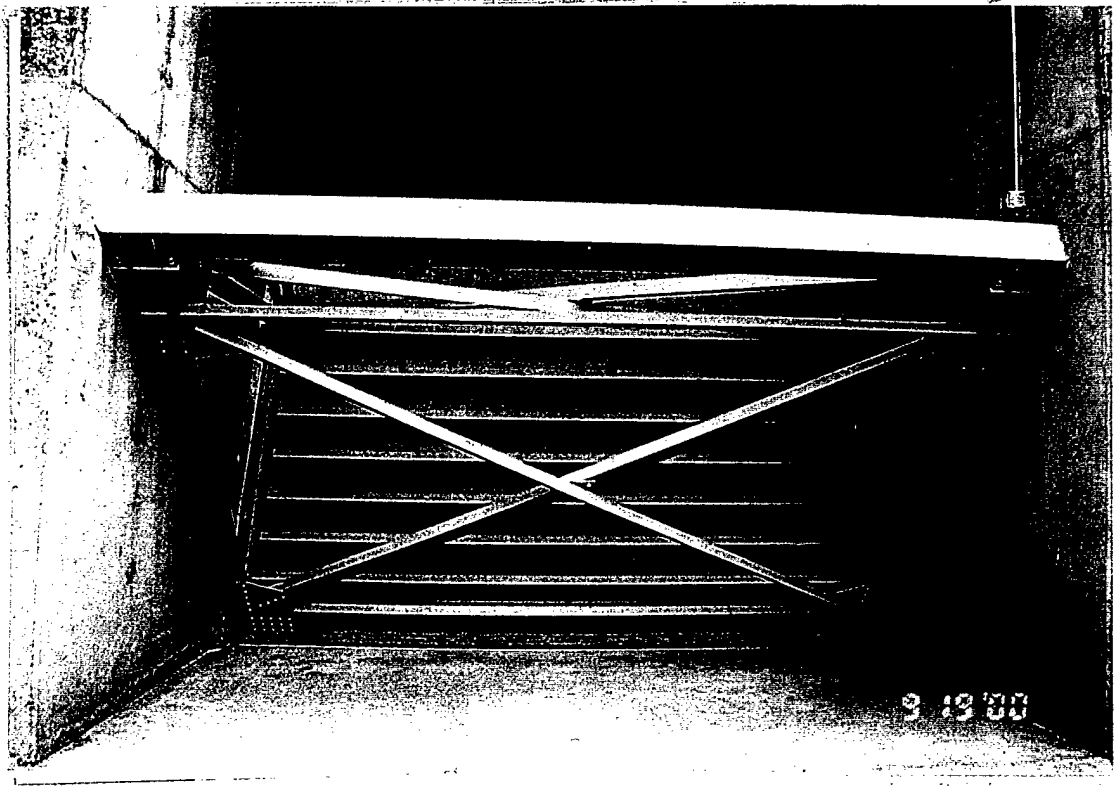
Gate 2 - 8'x18'  
Close-up side seal, typical.

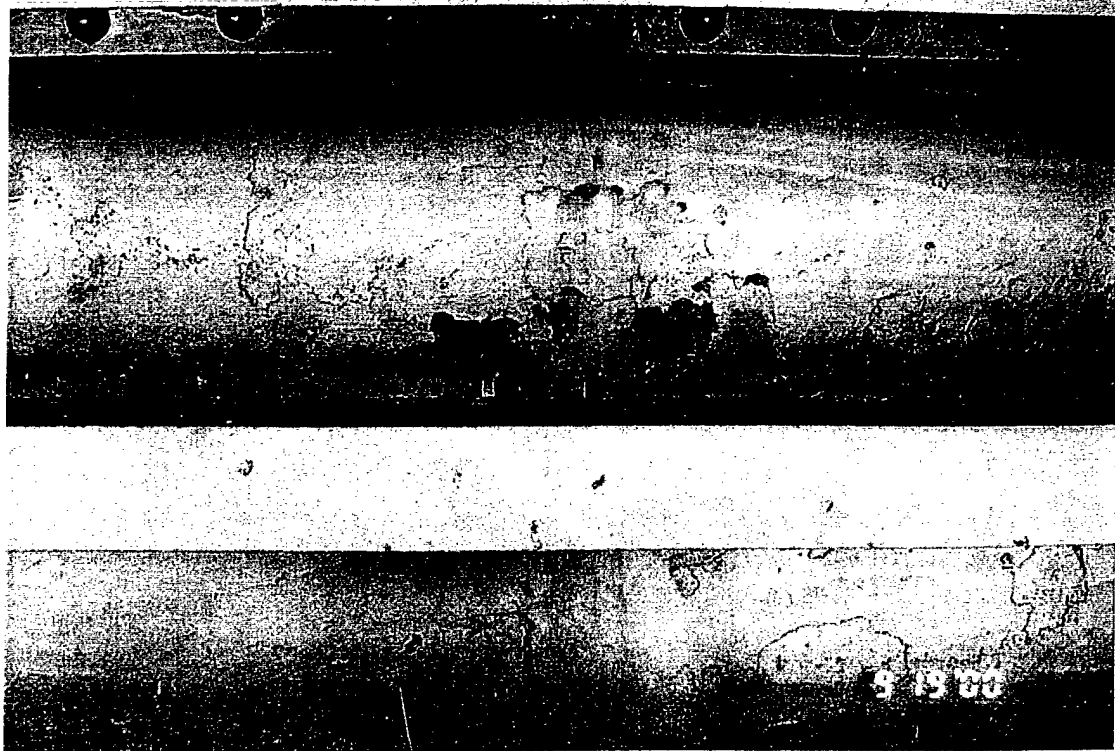
3-2

Gate 3 - 8'x18'  
Bottom horizontal girder and left side  
plate. Debris and clogged drain holes  
on bottom girder.

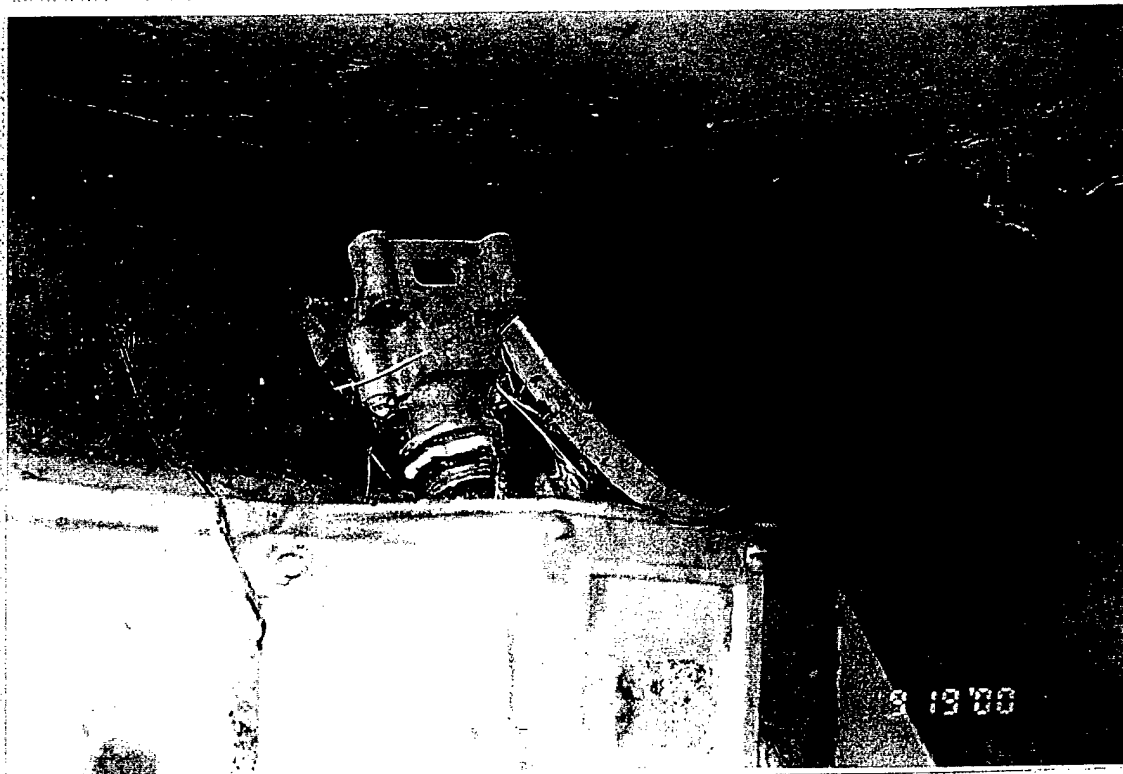
3-6

Gate 3 - 8'x18'  
Left hoist reduction pulley. Note:  
missing paint on pulley at previous  
location of hoist connection.

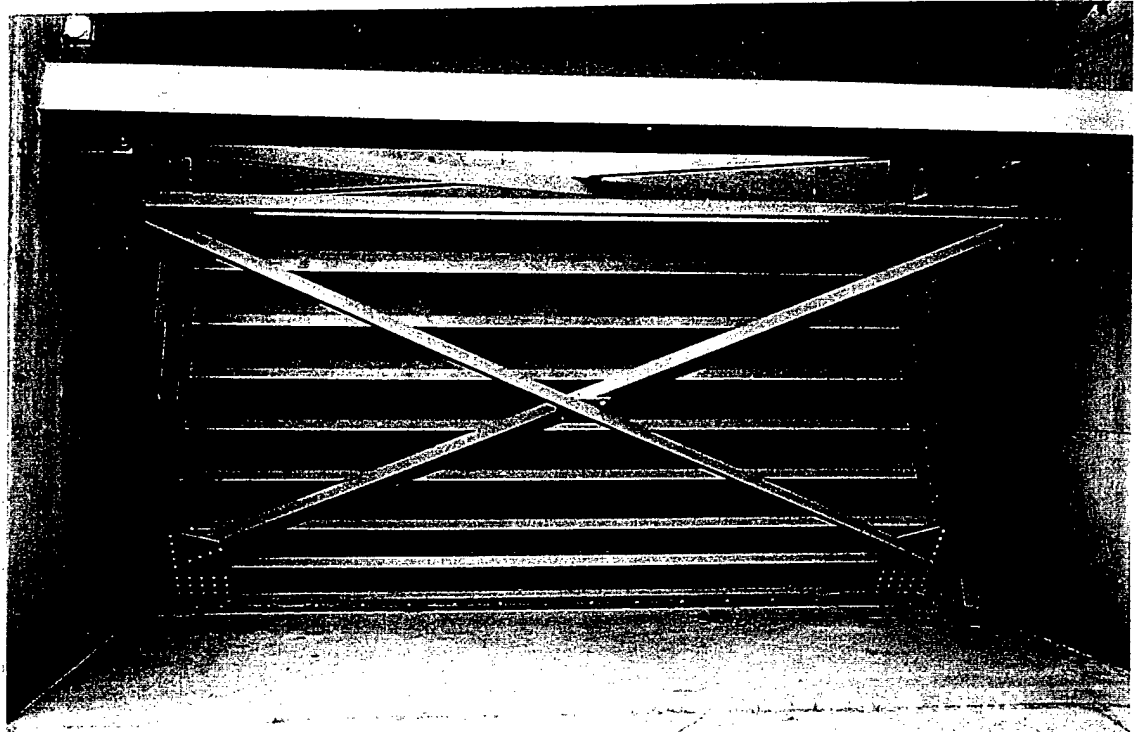
3-18

Gate 3 - 8'x18'  
Skin plate, typical.

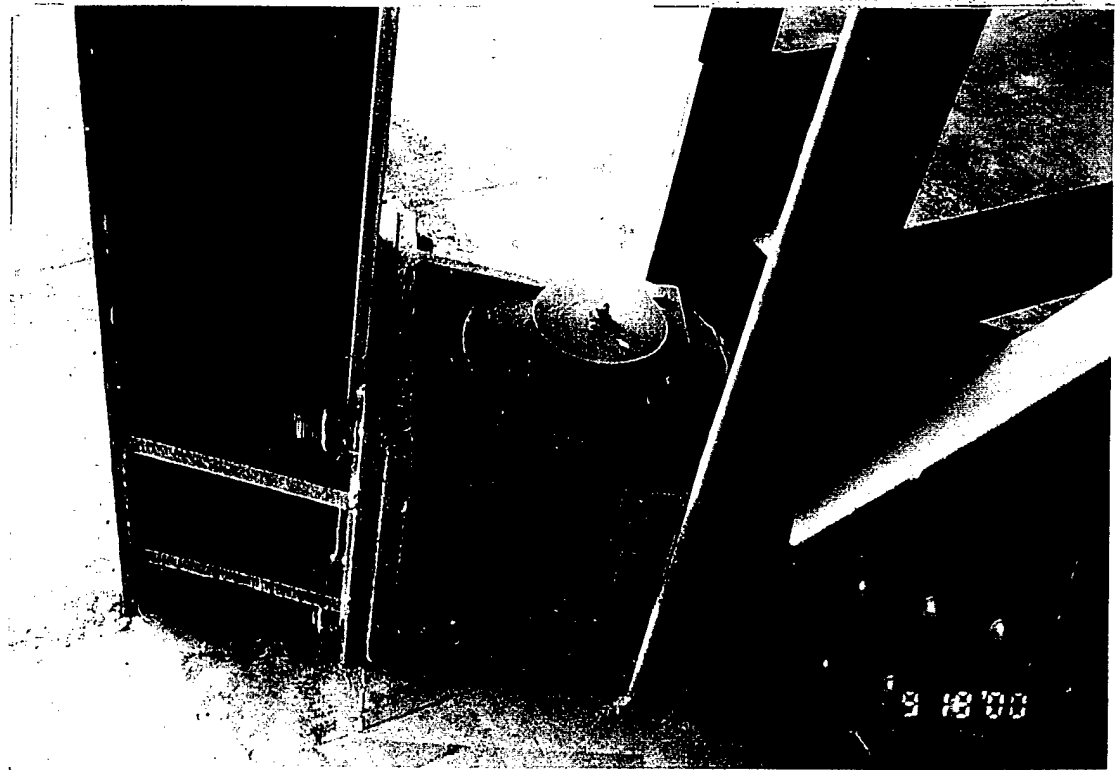
4-5

Gate 4 - 8'x18'  
Top of left trunnion and trunnion  
beam, typical.

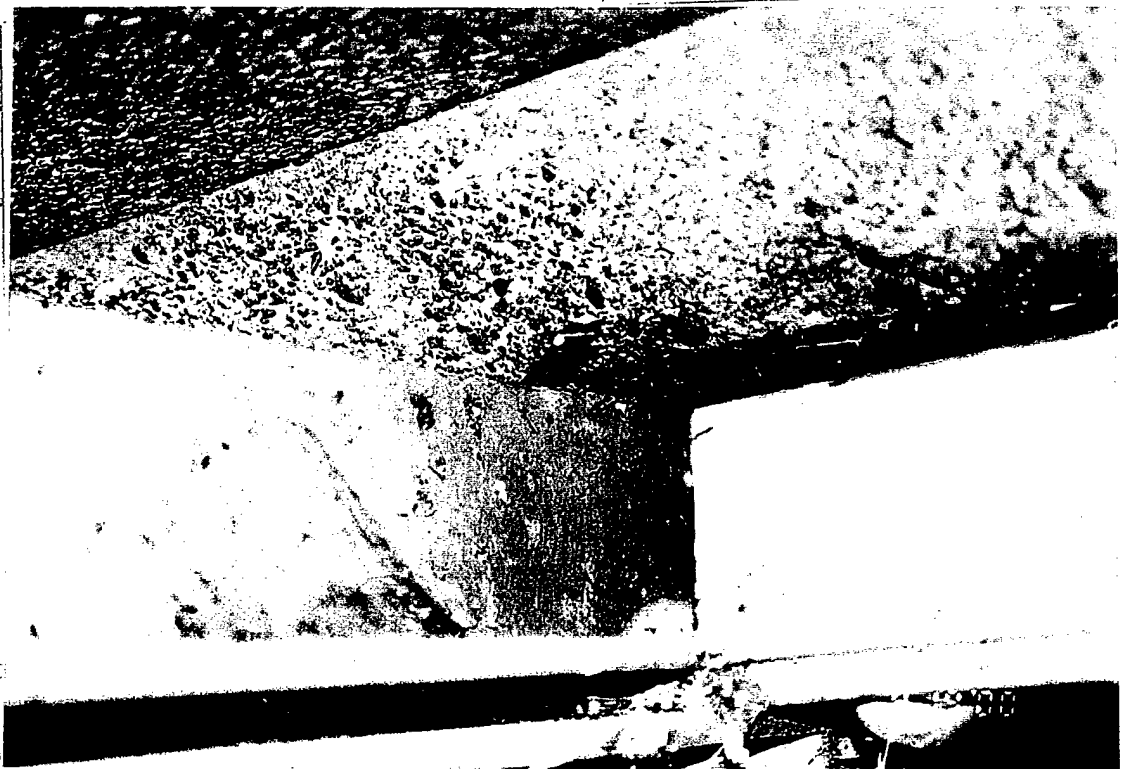
4-13

Gate 4 - 8'x18'  
Right frame. Bottom strut and side  
plate angle in contact with pier wall.  
Note: steel ruler between strut and  
pier.

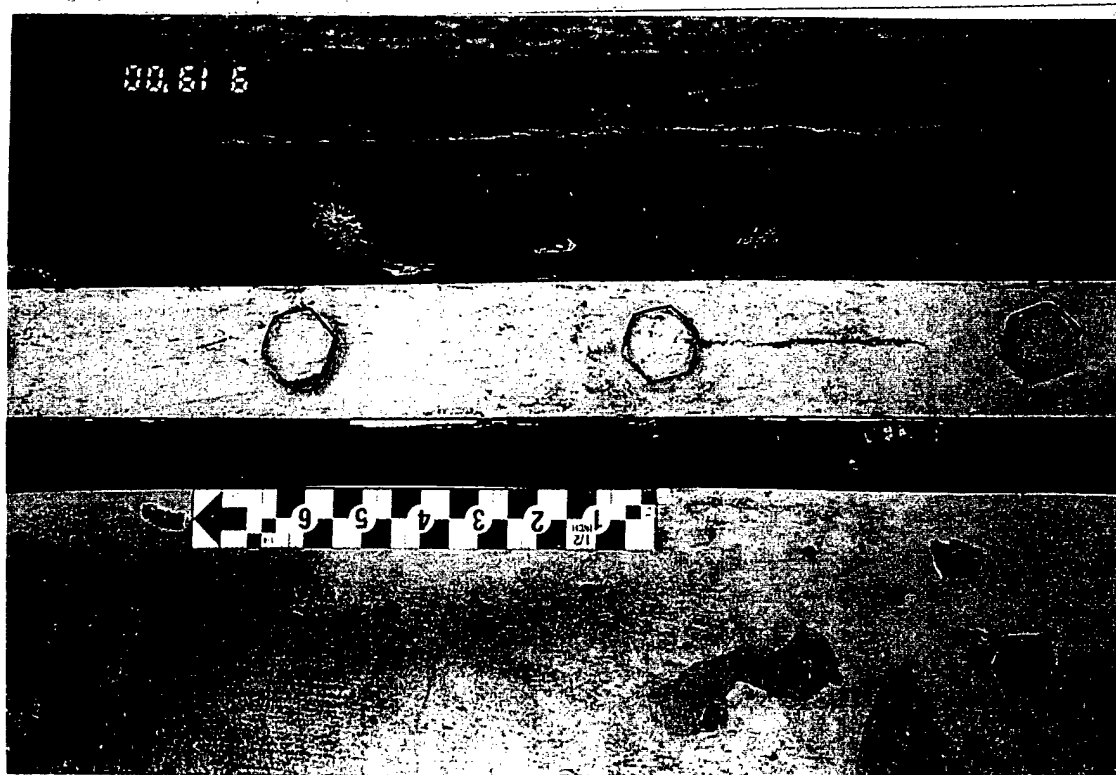
4-23

Gate 4 - 8'x18'  
Skin plate, typical.

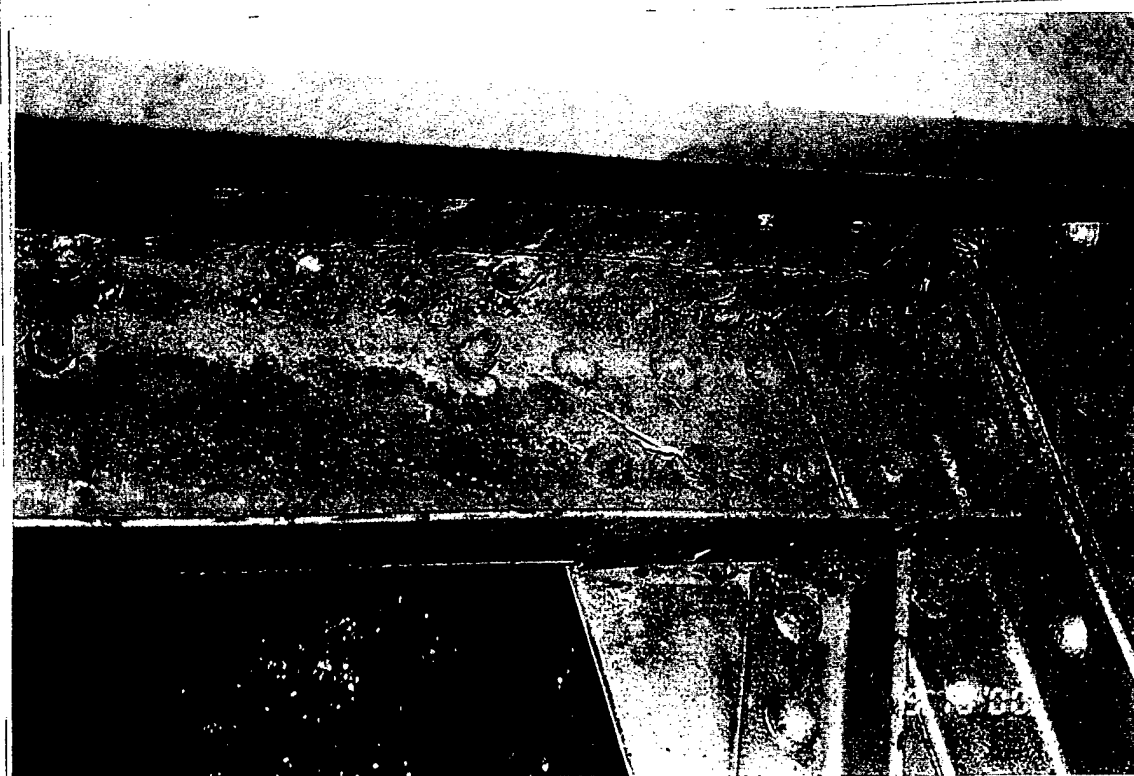
N-7

North Radial Gate  
Left hoist cable connection, typical.  
Side seal heater.
